# RIPARIAN HABITAT ALONG THE SACRAMENTO RIVER

Jim Gibson  
U.S. Army Corps of Engineers  
Sacramento, California

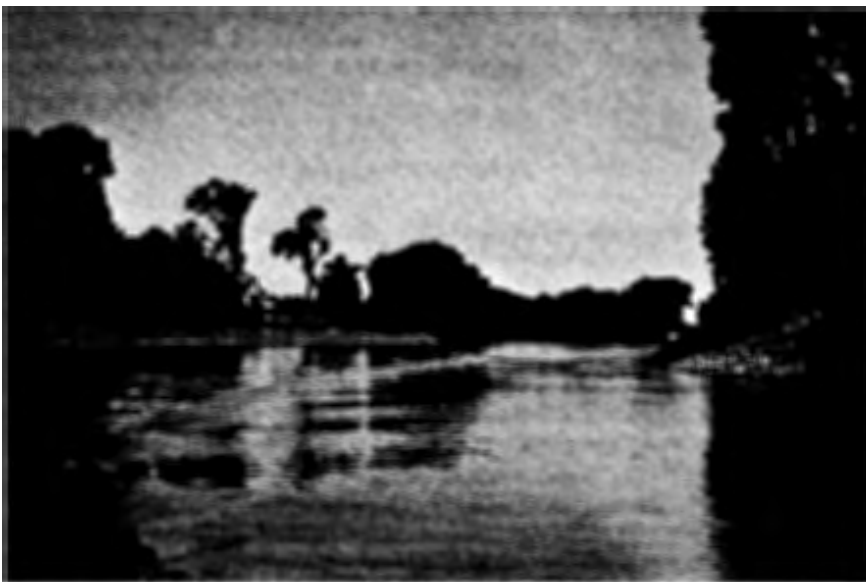
Figure 3. Riparian vegetation protected from future erosion by bank protection placed by waterborne equipment.

Numerous modifications of bank protection have been tested and evaluated recently to find ways to provide bank protection and also preserve the riparian vegetation remaining along the banks. The method most promising which preserves vegetation as well as preventing further erosion is the placement of bank protection using waterborne equipment. Very little vegetation is disturbed using this method since land-based equipment is not used for construction (Figure 3).

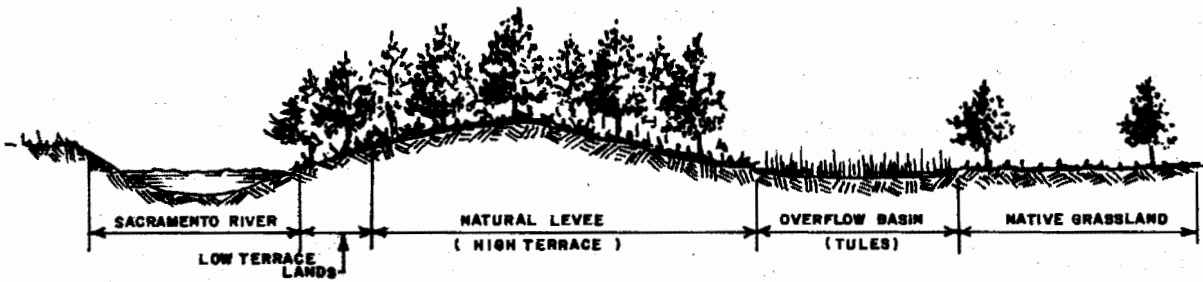
**FIGURE 4**  
**HISTORICAL CROSSSECTION OF**  
**LANDS ADJACENT TO THE RIVER**  
**Prior To Development**  
 ( NOT TO SCALE )

(1) Over half of the high terrace lands (Figure 4) supporting riparian vegetation (lands susceptible to flooding only during periods of very high flow) has been converted to other uses, primarily orchards.

(2) Riparian vegetation on low terrace lands (Figure 4) decreased only by about 4 percent (430 acres). Since low terrace lands are flooded nearly every year, development is very limited.

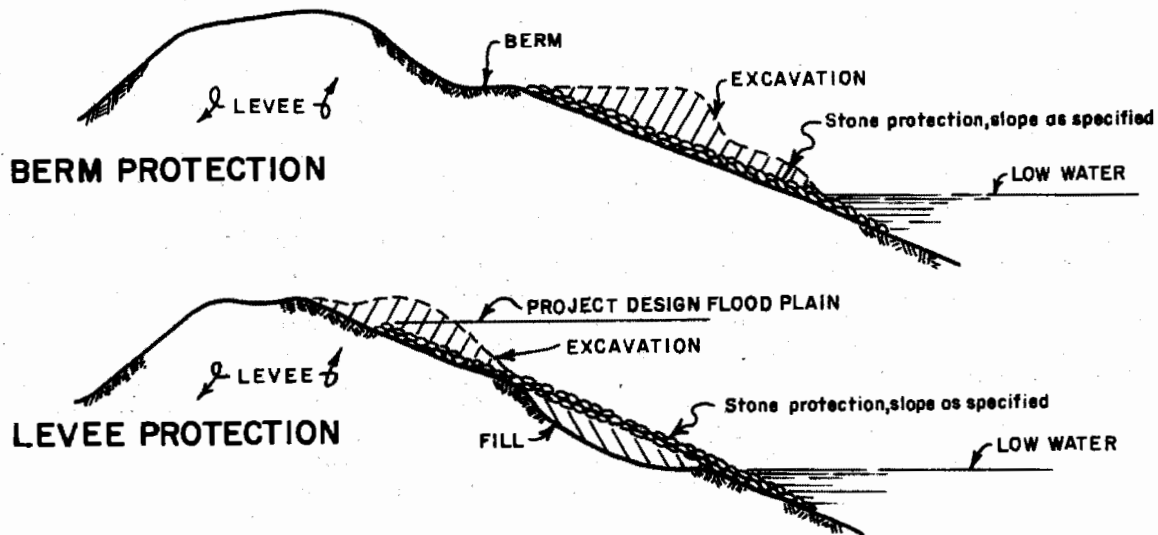
**FIGURE 5**

**STANDARD BANK PROTECTION DESIGNS**

Until recently, bank protection construction consisted of clearing vegetation from the bank or leveeslope, and then surfacing the slope with rock (Figure 5). Conservationists have been particularly critical of this type of construction because it has resulted in destruction of wildlife habitat. Also, maintenance of the completed work by local reclamation districts has not allowed vegetation to regrow.
