GOSHUTE CREEK HABITAT IMPROVEMENT FOR AN ENDANGERED SUBSPECIES OF CUTTHROAT TROUT

Wayne D. Logan
Bureau of Land Management
Ely, Nevada

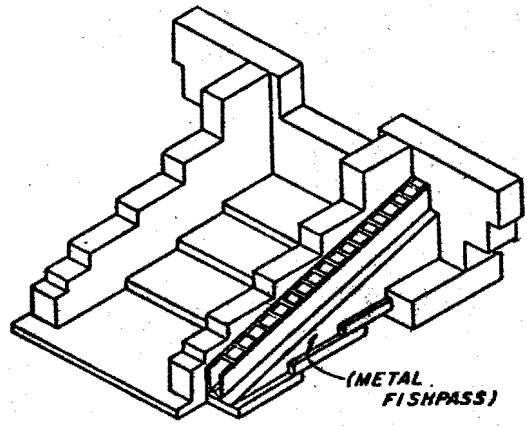
Fig. 1. Isometric drawings of the gabion (upper) and weir (lower) structures for the lower facility.

The upper gabion is actually three structures stairstepped down the lower side of the canyon dam to lower the stream channel 21 feet. This complete structure is approximately 60 feet long, 30 feet wide, and 28 feet high (Fig. 1). It has a 10-foot wide spillway to accommodate heavy spring runoff. No fish passage is provided in this structure. This gabion was completed first.

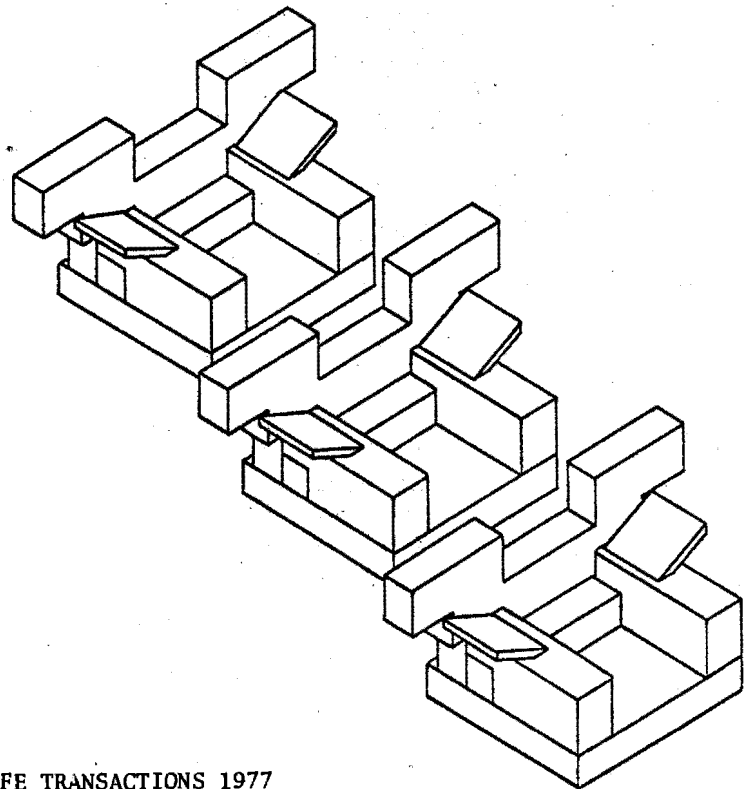
Fig. 2. Isometric drawing for the gabion constructed at the upper facility.

a side panel (Fig. 2). The fish pass is set at approximately 26° and placed so that all normal flow passes through the fish pass; only heavy spring runoff will flow over the spillway (Fig. 2).

The small weir is a gabion placed 30 feet upstream from the lower gabion to maintain the stream channel in a constant location as it approaches the lower gabion. This structure is 6 feet long, 30 feet wide, and 5 feet high; it was the last structure to be completed (Fig. 2).

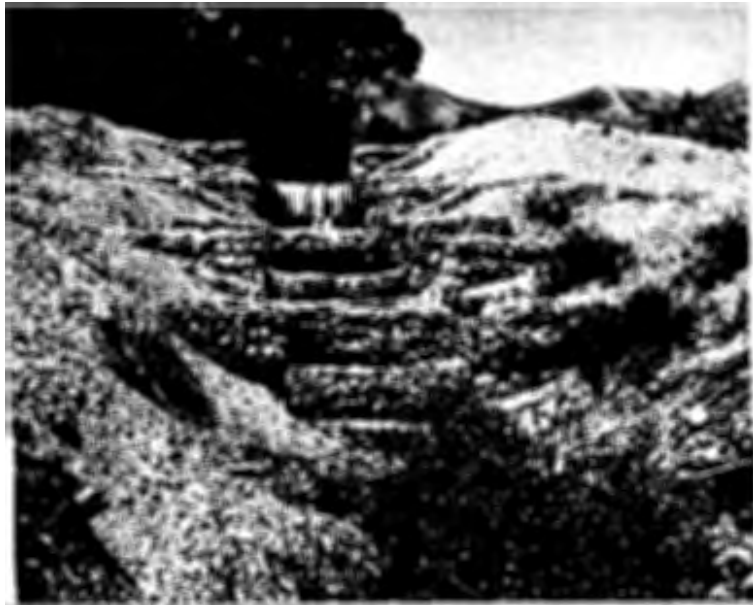
Fig. 3. The upper gabion after completion of construction.

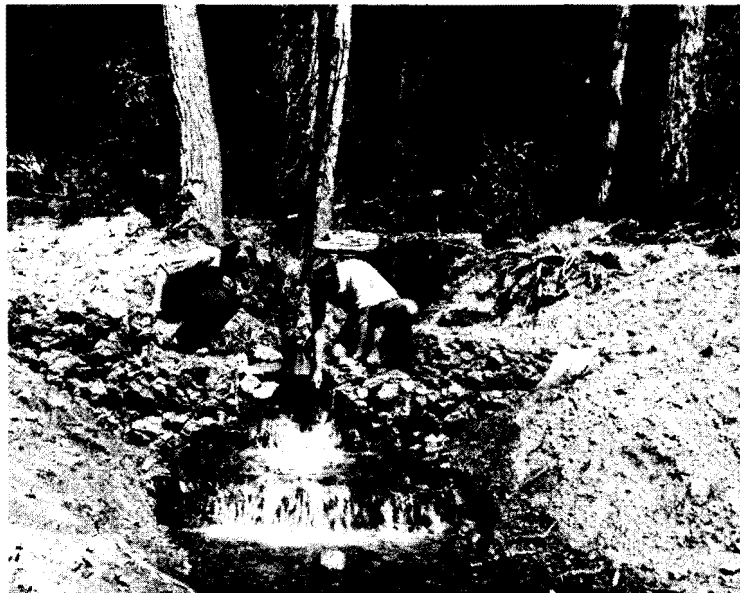
Fig. 4. One of the weirs completed at lower facility.
